**DEPARTMENT OF TRANSPORTATION****DIVISION OF ENGINEERING SERVICES**

Quality Assurance and Source Inspection

Contract #: 04-0120F4Cty: SF/ALA Rte: 80 PM: 13.2/13.9File #: 13.28**WELDING INSPECTION REPORT****Resident Engineer:** Pursell, Gary**Address:** 333 Burma Road**City:** Oakland, CA 94607**Report No:** WIR-012858**Date Inspected:** 26-Mar-2010**Project Name:** SAS Superstructure**OSM Arrival Time:** 1000**Prime Contractor:** American Bridge/Fluor Enterprises, a JV**OSM Departure Time:** 1830**Contractor:** Oregon Iron Works Clackamas, Or.**Location:** Clackamas, OR**CWI Name:** M. Gregson, J. Salazar**CWI Present:** Yes No**Inspected CWI report:** Yes No N/A**Rod Oven in Use:** Yes No N/A**Electrode to specification:** Yes No N/A**Weld Procedures Followed:** Yes No N/A**Qualified Welders:** Yes No N/A**Verified Joint Fit-up:** Yes No N/A**Approved Drawings:** Yes No N/A**Approved WPS:** Yes No N/A**Delayed / Cancelled:** Yes No N/A**Bridge No:** 34-0006**Component:** Hinge K Pipe Beams**Summary of Items Observed:**

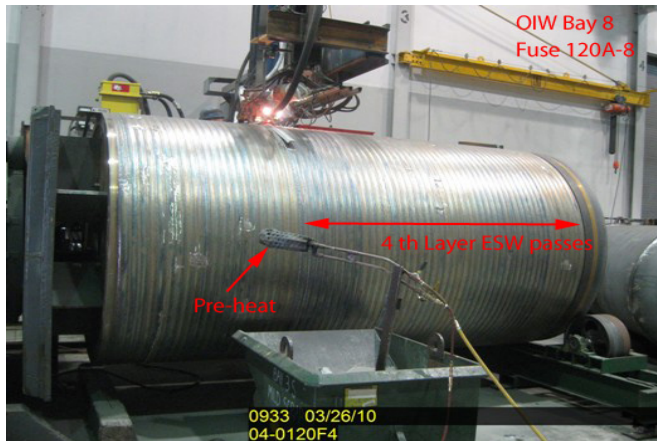
### Hinge-K Pipe Beam Assembly 120A-8:

The QA Inspector witnessed welder WID #F17 (Igor Frolov), performing electro slag welding (ESW) on the fourth layer welding passes, in the flat position. The QA Inspector noted that the fourth layer pass was now approximately 75% complete and Soudokay brand Soudotape 316L stainless steel consumable strip, was being utilized. The QA Inspector randomly noticed QC Inspector Jose' Salazar was present, to verify in-process welding parameters (amps/volts) and monitor in-process continuous pre-heat temperatures. QC Inspector Salazar explained to the QA Inspector that welding amperage was previously recorded at 1250 amps/25.7 volts, travel speed at 267 mm/min. and a pre-heat temperature recorded at approximately 150 degrees Fahrenheit (66 C). The QA Inspector verified the welding parameters and the minimum pre-heat temperatures were in compliance with the applicable WPS 7003. The QA Inspector verified WID #F17 was currently qualified for this welding process and position and that the ESW being performed, appeared to be in compliance with WPS 7003. see attached picture below.
